Project title	Structural Finite Element Analysis: Rotor Modification Assessment Traction Motor
Date	June 2020

SCOPE/OBJECTIVE

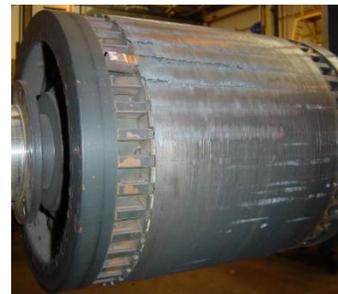
DMKT 52/24 Traction Motor Rotor with Failed Rotor Bars.
