Project title	Structural Finite Element Analysis: Rotor Modification Assessment Traction Motor
Date	June 2020

SCOPE/OBJECTIVE

Due to frequent in-service failures of the rotor bars on Passenger Train traction motors especially at the rotor bar connection to the endplates which had often resulted in breaking a number of lugs away from the rotor core, a design modification was implemented to resolve this issue, however, failures have continued to occur.

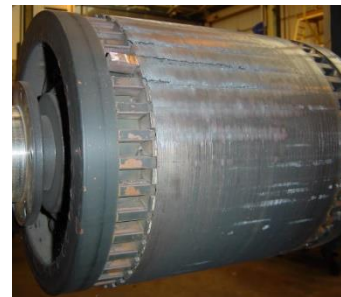
DMKT 52/24 Traction Motor Rotor with Failed Rotor Bars.

Our client developed an alternative solution using a modified rotor endplate to better support the rotor bars. The modification consists of the addition of protrusions on the outer edge of the two endplates of the rotor; these protrude between the rotor bars giving additional support to them between the end rings.

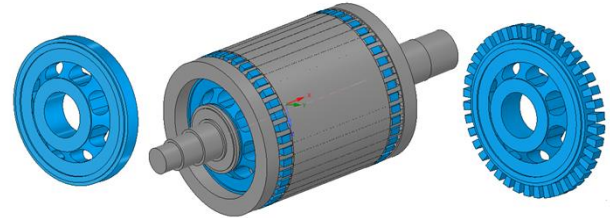
A Rotor CAD Model with original (left) and modified (right) endplates where protrusions are introduced to the assembly.
